**Shoreline retreat of a degrading mangrove forest
in Sungai Besar, Selangor, Malaysia****Introduction**

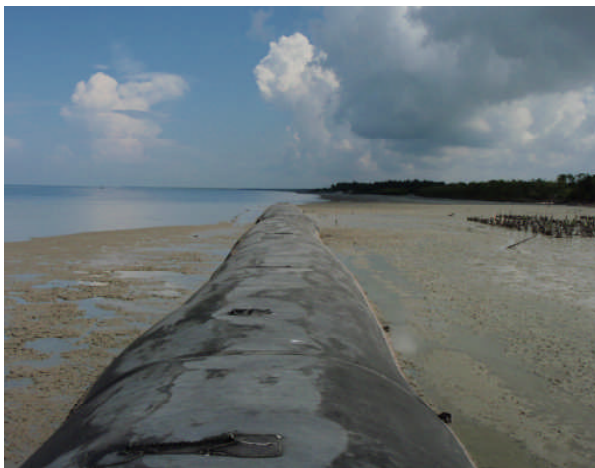
Fig. 1. One of the four geotubes in Sungai Haji Dorani

Coastal erosion of muddy shores has become a serious problem threatening mangrove forests, agricultural crops, settlements and aquaculture ponds. The National Coastal Erosion study in 1986 alerted that 29% of the Malaysian coastline was in various stages of retreat (Ghazali, 2006). The progressive degradation of mangrove forests and loss of land prompted new protective measures such as the installation of geotubes to act as barriers to ameliorate high intensity waves that erode the shoreline. Geotubes are high strength woven geotextile filled with slurry of sand and water (Fig. 1). In Sungai Haji Dorani (3°38'N, 101°01'E), Sungai Besar in Selangor, Malaysia, four units of geotubes were installed to reduce the impact of erosion and mangrove degradation. The objective of our study was to assess the effectiveness of these geotubes in reducing coastal erosion and protecting the remaining mangrove belt.

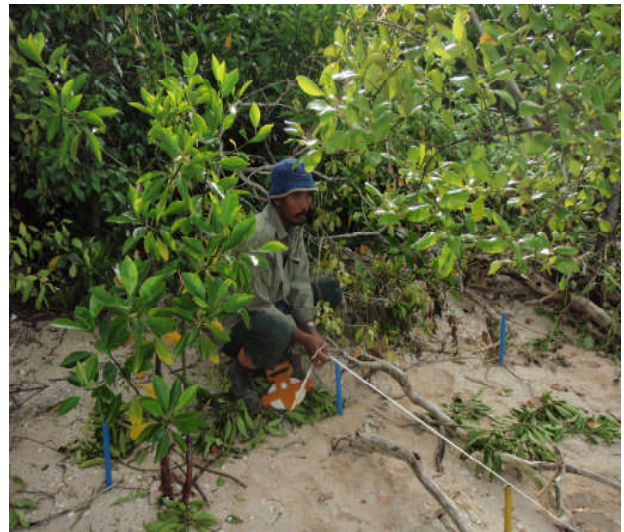
Fig. 2. Measuring the eroding scarp from the baseline

Six (4 x 4 m) quadrats were set up in each plot to determine species composition. Data on tree genera and diameter were collected on a bimonthly basis. Only trees with measurable bole diameters at 1.3 m height were reported. Experimental plots were established, one with geotubes (T1) and the other without geotubes (T2). Each plot had a 50 m long baseline aligned parallel to the eroding shore. Plastic pipes (0.5 m in length) were implanted at 1 m intervals along the baseline. The pipes with 30 cm exposed were painted and they each served as pins for measuring the perpendicular distance of the eroding scarp on a bimonthly basis (Fig. 2).

Subtracted values from the previous measurements for each pin would give the rate of shoreline retreat. The mean distance for each pin was calculated from February 2008 to February 2010 to estimate of the rate of erosion. For this study, only 27 pins were accounted for due to severe sand accumulation in May 2008. The pins were not replaced to reduce errors of measuring the distance of the eroding scarp. The mean erosion (m) was the sum of erosion at each pin divided by the number of remaining pins and expressed as mean erosion rate (m/yr). Area eroded (ha) was calculated by multiplying remaining baseline length (27 m) with the mean erosion.

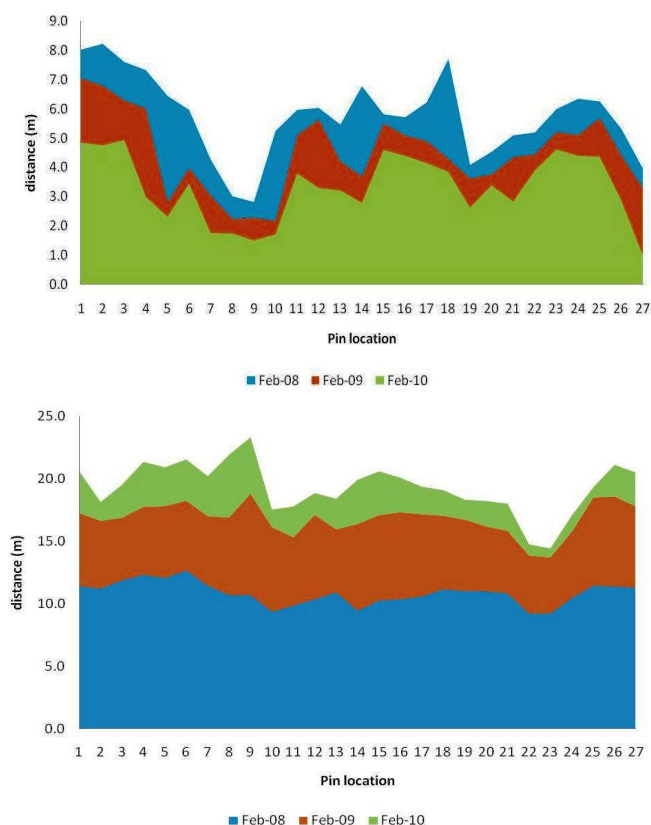
Fig. 3. Retreat of eroding scarp in T1 with geotubes (top) and in T2 without geotubes (bottom) from 2008 to 2010

Retreat of the eroding scarp based on distance from the baseline in T1 (with geotubes) and in T2 (without geotubes) from 2008 to 2010 is shown in Fig. 3.

In T1, the mean distance from the eroding scarp to the baseline significantly decreased by 35 m in 2009 and 31 m in 2010 (Table 2). However, the decrease was more pronounced in T2, 132 and in 2009 and 94 m in 2010. It was estimated that the mean erosion rate for T1 was between 1.1 and 1.3 m/yr and 3.5 to 4.9 m/yr for T2. Thus, the area of erosion was relatively higher in T2 (0.10 ha) than in T1 (0.03-0.04 ha). The loss of species, and declines in mean abundance and basal area in both plots were mainly due to severe erosion caused the scouring effect of the substrate and retreat of the eroding scarp. The uprooting and collapsing of trees was widespread in T2 (Fig. 4). Trees may have also succumbed to other environmental stresses such as increased salinity, wave tidal dynamics and wind effects that can degrade mangroves (Kathiresan, 2002).

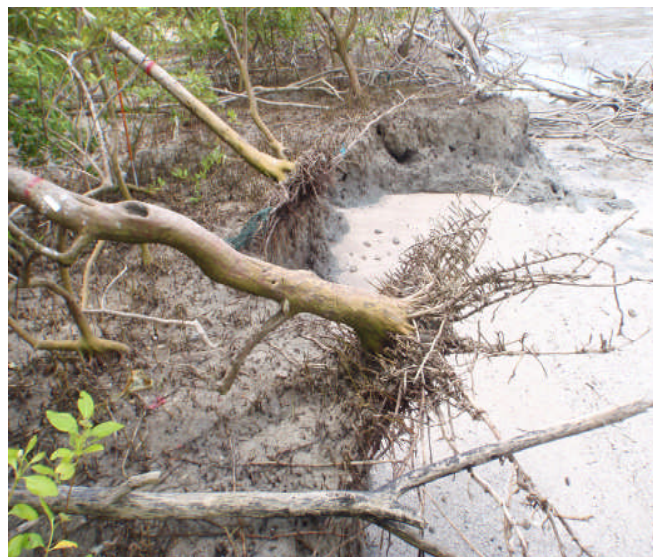
Fig. 4. Widespread uprooting and collapsing of trees in T2 (without geotubes)
